TECHNICAL REPORT M-286  
January 1981

CORROSION CONTROL OF PILINGS IN SEAWATER:  
BUZZARDS BAY

by  
A. Kumar  
R. Lampo  
A. Beitelman

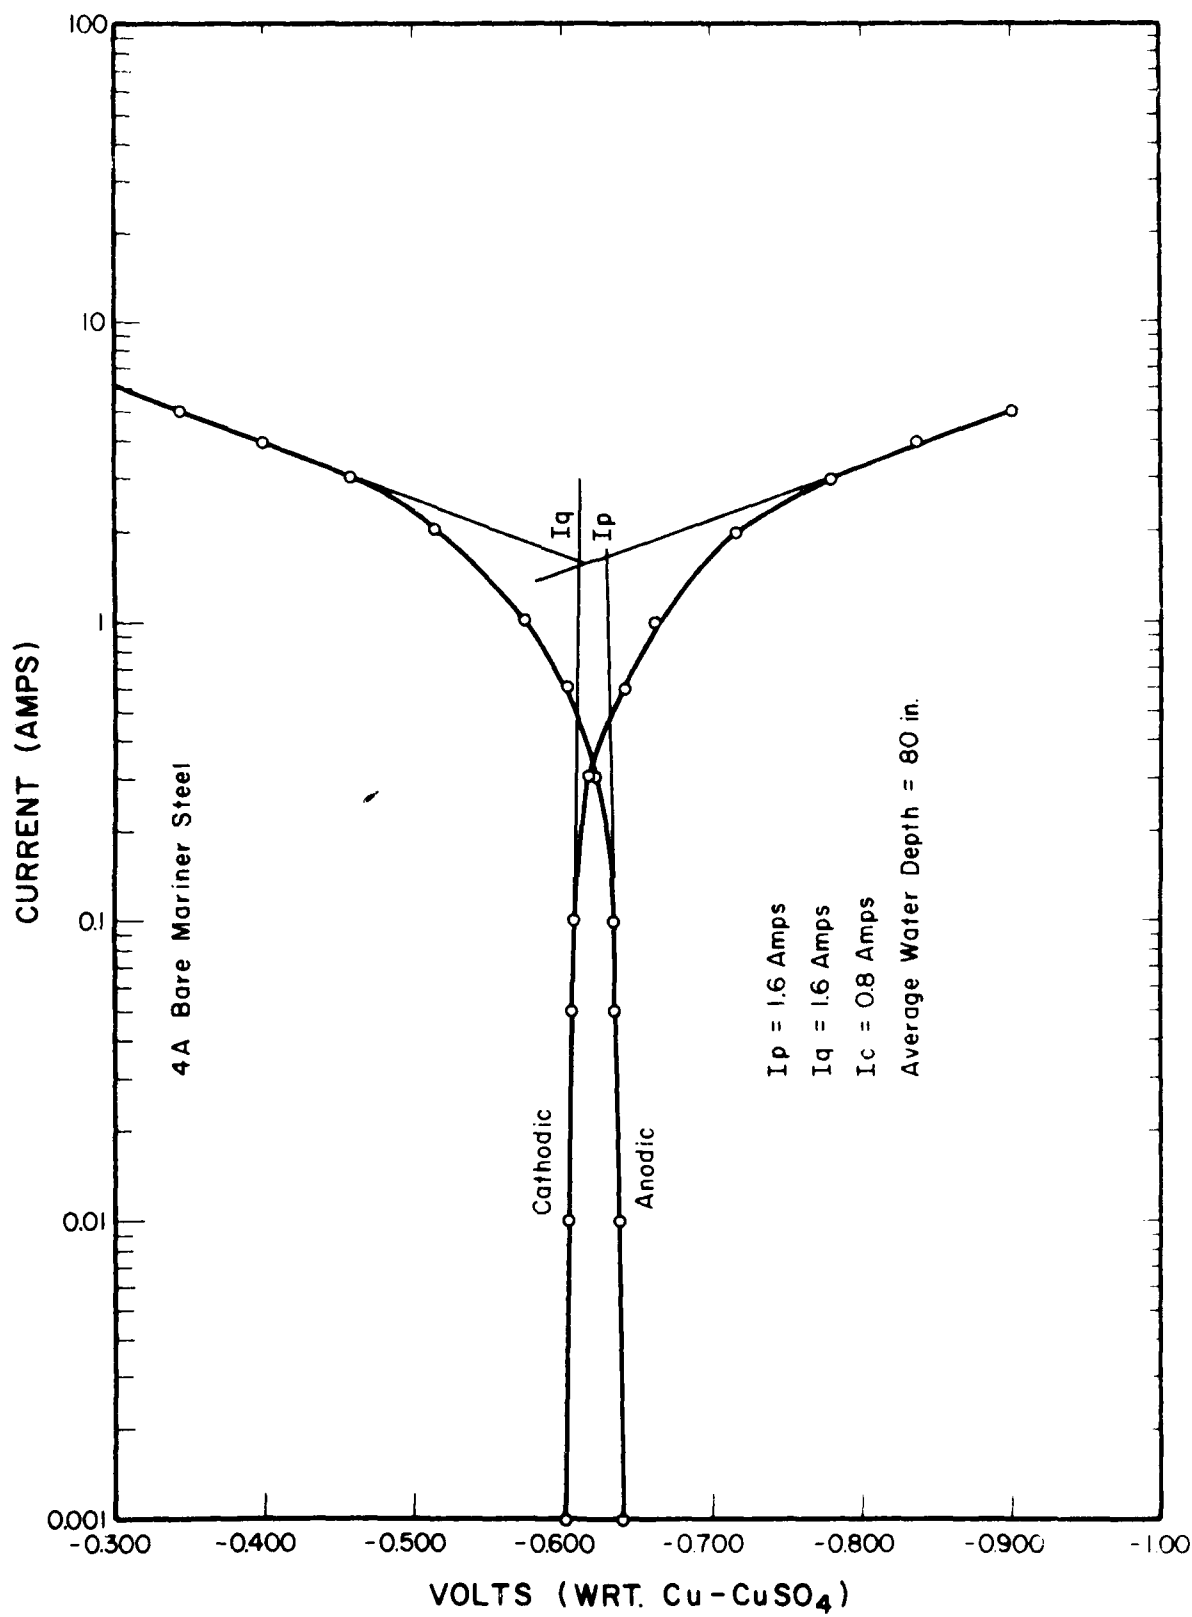
Figure 8. Polarization characteristics of bare carbon steel (ASTM A 36).

The corrosion rate or rate of metal loss can be determined from the average corrosion current density: the higher the corrosion current density, the higher the metal loss or the corrosion rate.<sup>10</sup> In 1979, the corrosion current (as calculated from Eq 2) for bare carbon-steel pile 1A was 0.8 amp, and for Mariner steel pile 4A, also 0.8 amp (Figure 8 and Figure 9).  $I_p$  and  $I_q$  were determined by extending the tangents of linear portions of the curves and determining their intersection, as shown in Figures 8 and 9.

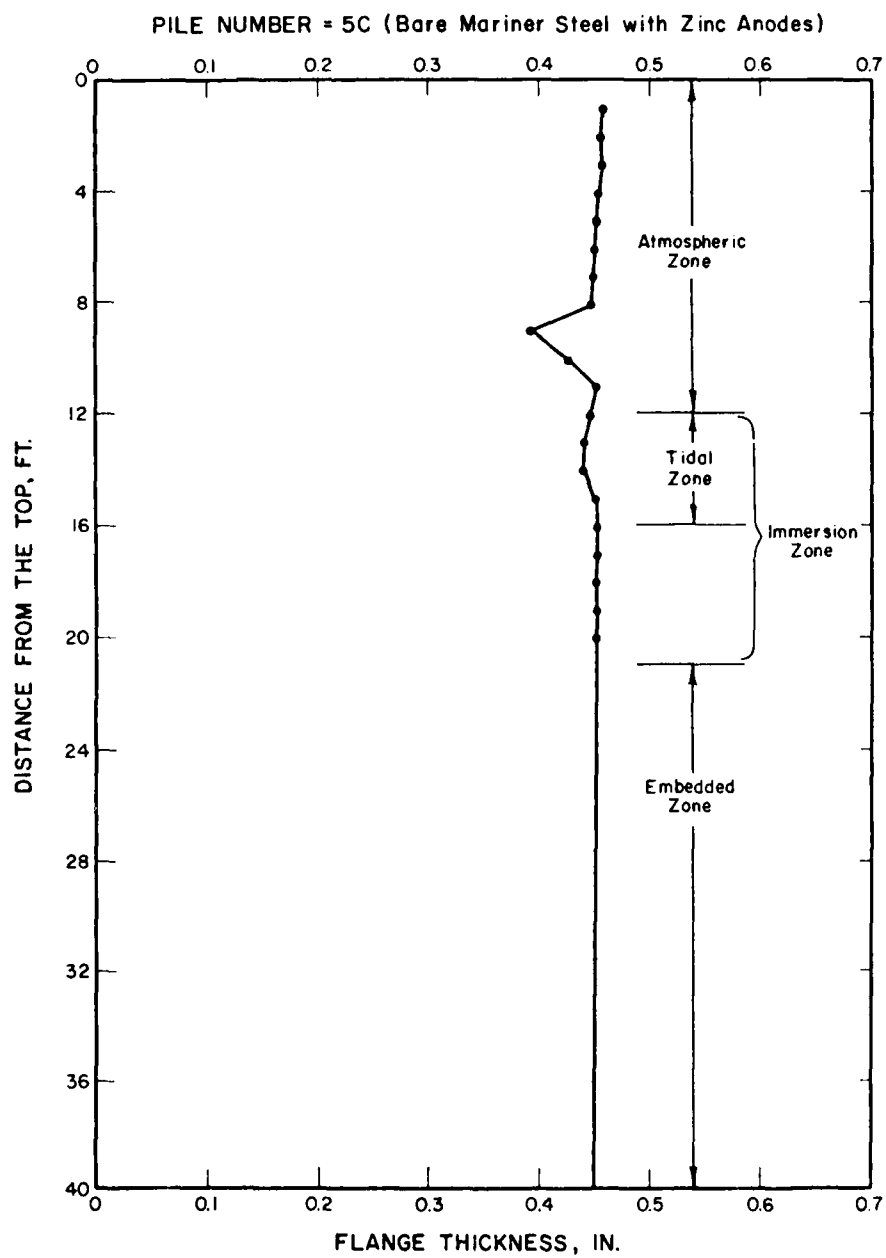
Figure 15. The flange thickness of bare Mariner steel (ASTM 690) pile with sacrificial zinc anodes at various depths.

The flange thicknesses of the bare and cathodically protected pilings are shown in Figures 10 to 15. It is observed that the average corrosion rate of bare carbon steel (A 36) in the immersed zone (excluding tidal zone) is 3.4 mils/yr. The corresponding average corrosion rate for bare Mariner steel (ASTM 690) in the immersed zone is 1.4 mils/yr. Sacrificial anodes reduced the corrosion rate to zero in the immersed zone.
